LANDSCAPE CONCEPTS PROPOSED MOUNT ISA LOOKOUT REVITALISATION

ISSUE D

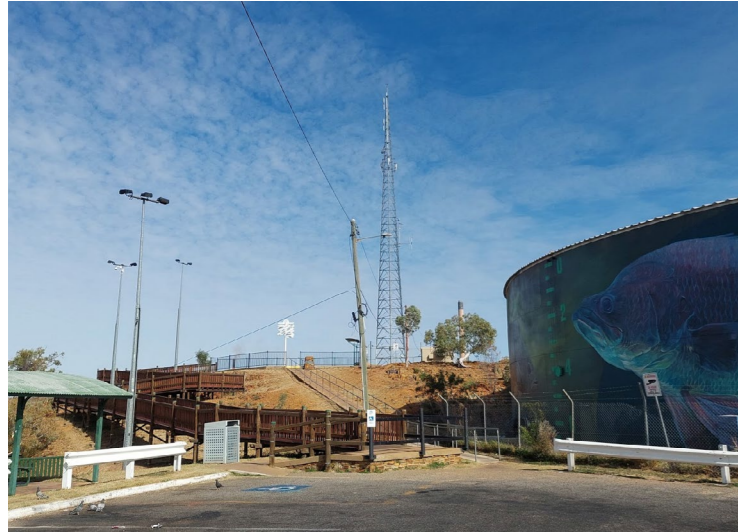
The lookout contains a collection of old infrastructure that is cluttered and detracts from the beauty of the lookout.

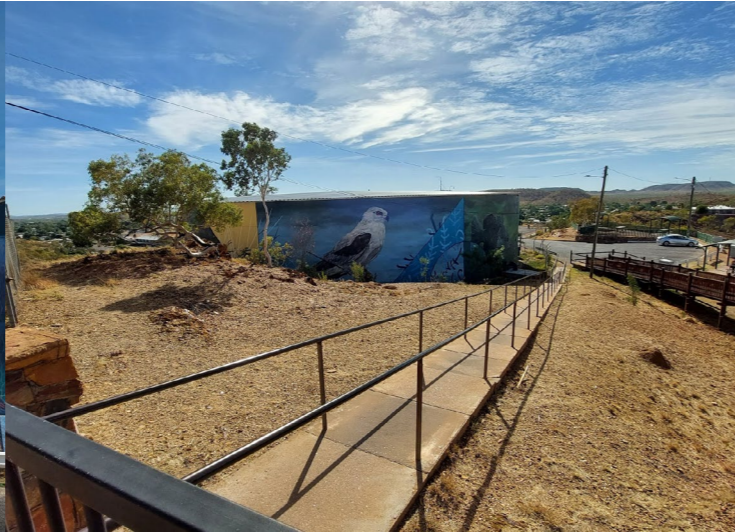
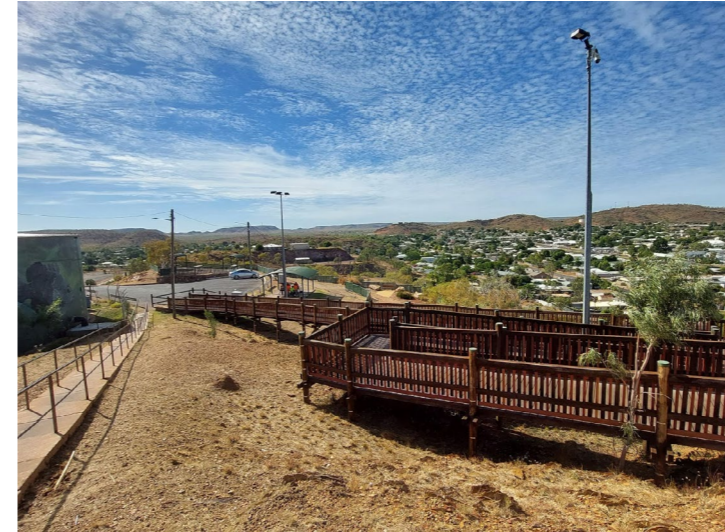
Two walkways up to the lookout is unnecessary. Boardwalk up to the lookout is old, unsightly, and falling apart. Pathway with metal fencing up to lookout is narrow unsightly.

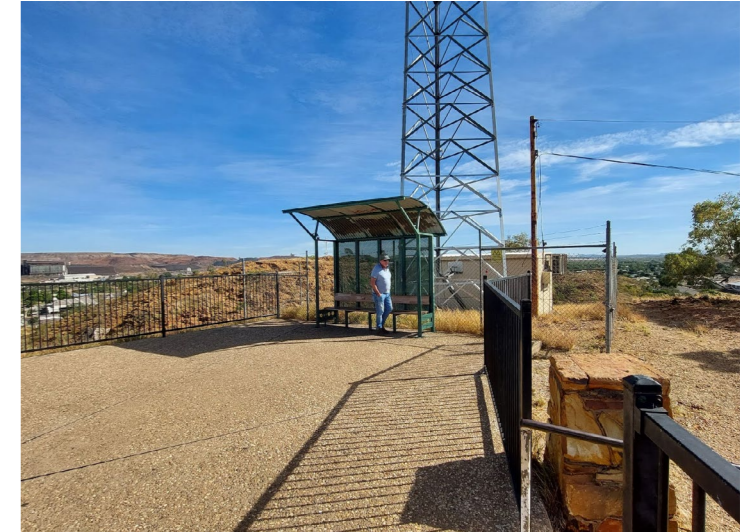
Unnecessary Bus Stop at the top of the lookout. High fences also added a corralling nature of the lookout.

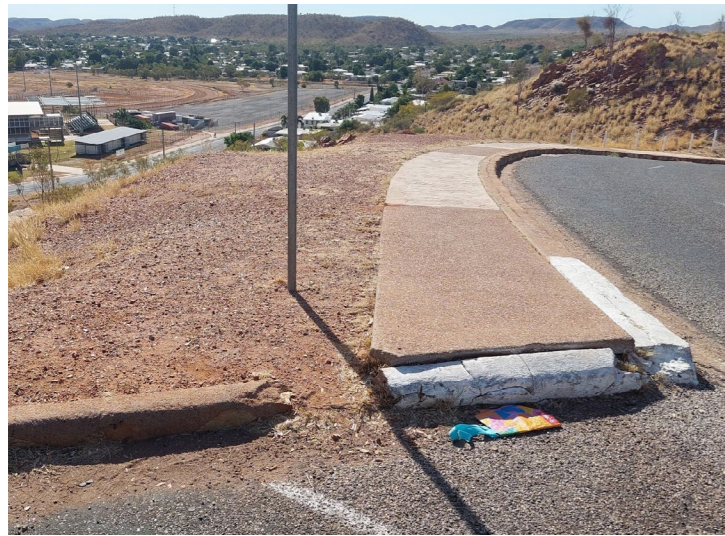
Inadequate pathways to get up to the lookout. People are seen walking on the road to get to the lookout. Linking Paths are incomplete.

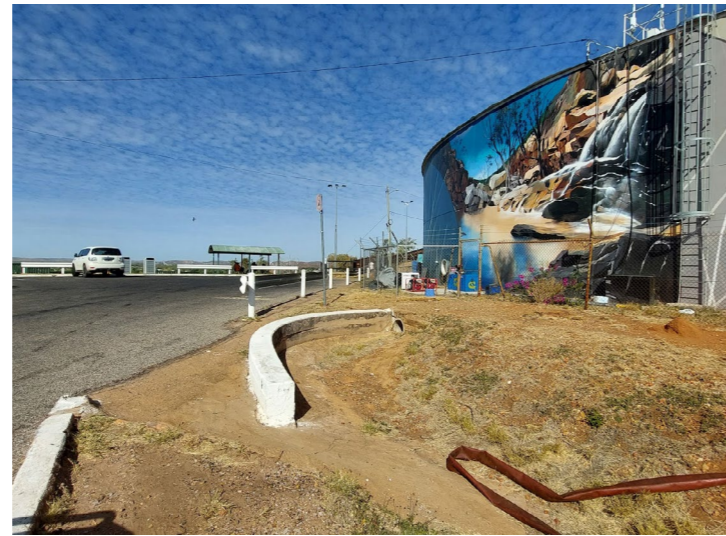
Lack of Pathways within the site can be dangerous and severely inconvenient for visitors.

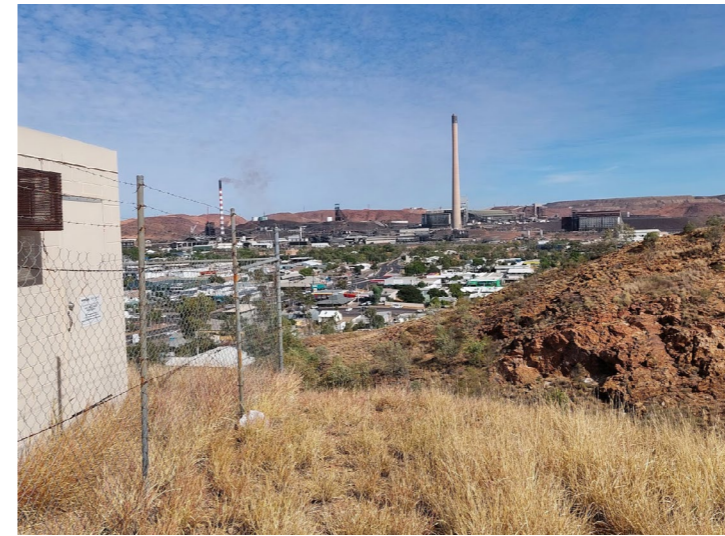
Fences with barbed wire are dangerous and are unsightly.

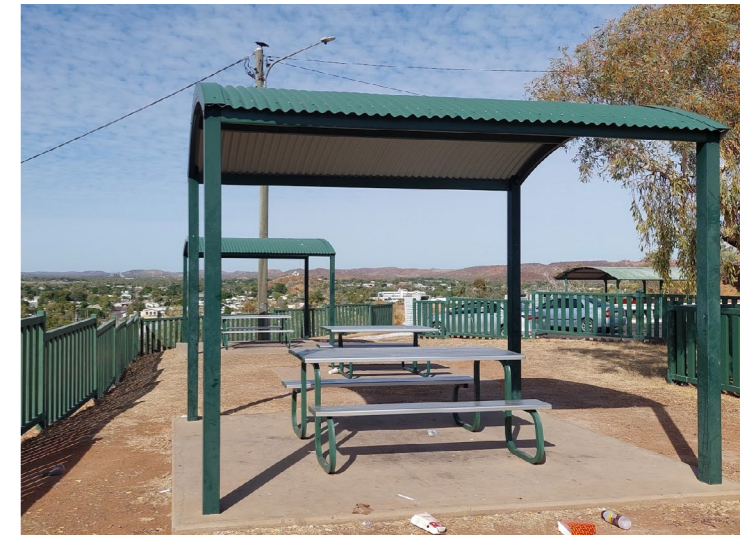
No Toilet facilities and drinking fountains. Structures are dated and unsightly.

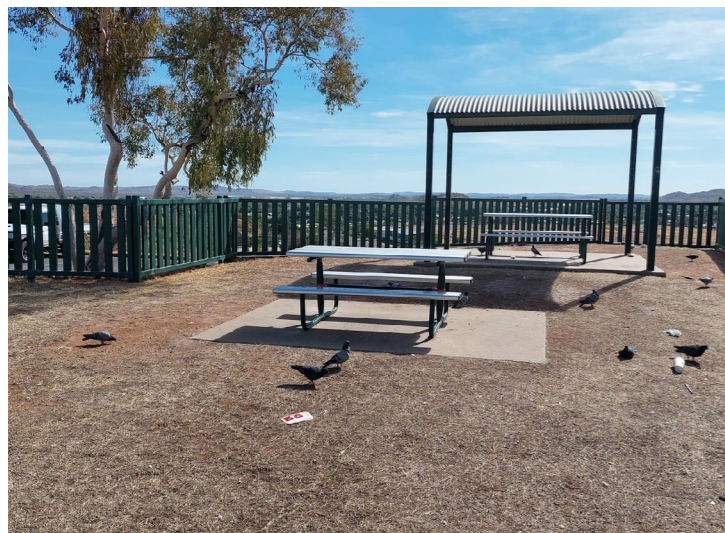
Pigeon problem not helped by presence of rubbish.

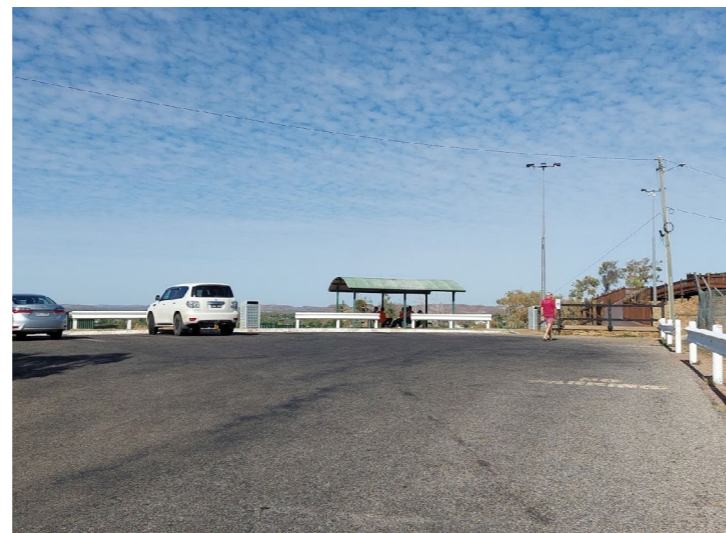
Lack of Car parks available, problematic because of the popularity of the lookout. Turn around is not ideal.

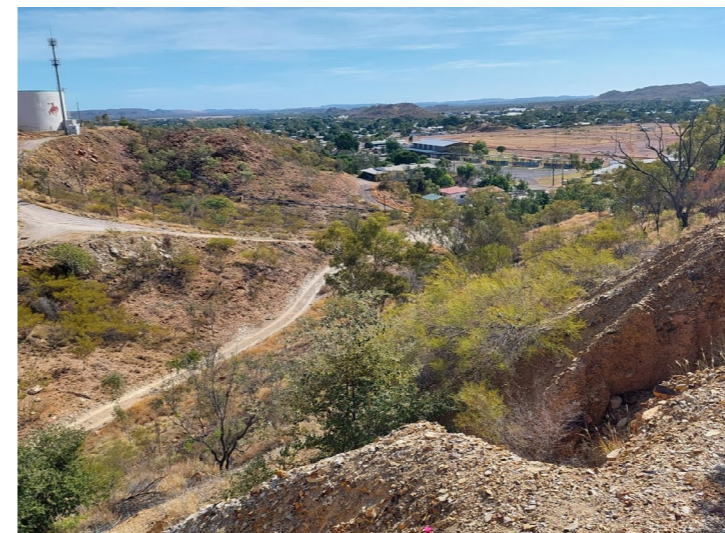
Some dangerous holes and cliff edges in and around the lookout.

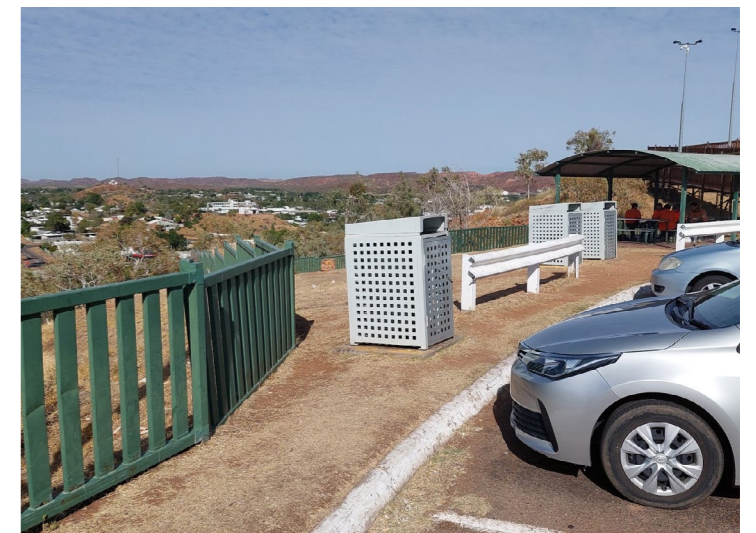
Excessive use of and poorly located refuse bins which appear to be unused considering litter is present throughout the whole site.

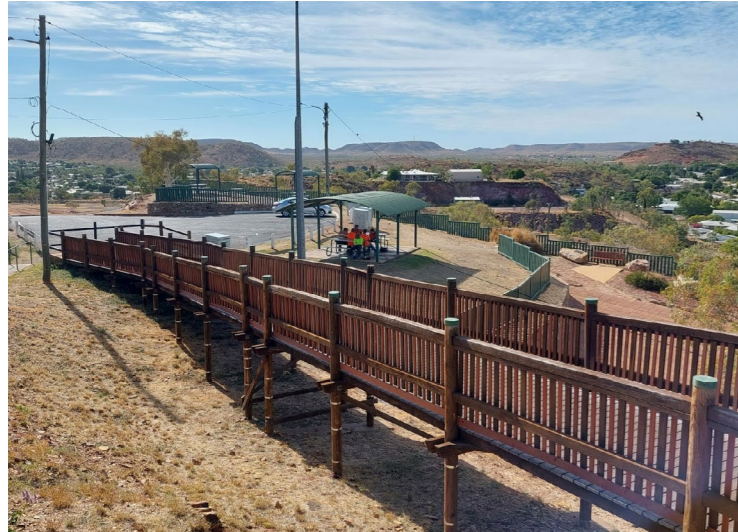
Too much unnecessary and unsightly railings, fences, powerlines, and light posts. Creates a visual clutter that detracts from the natural landscape.

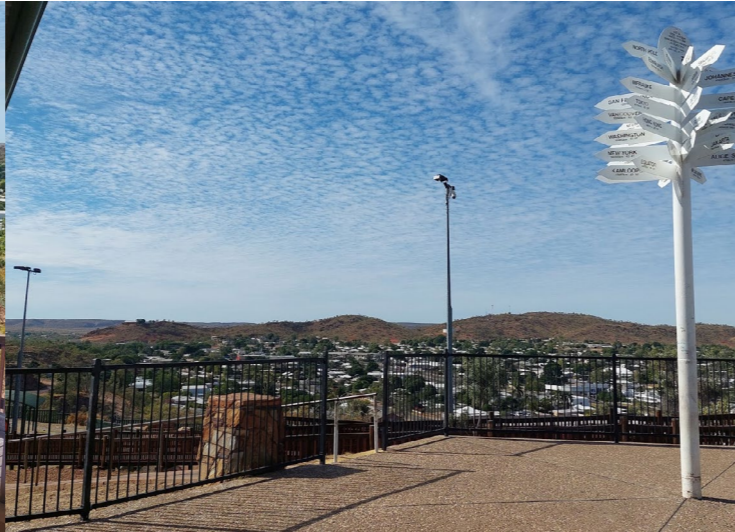
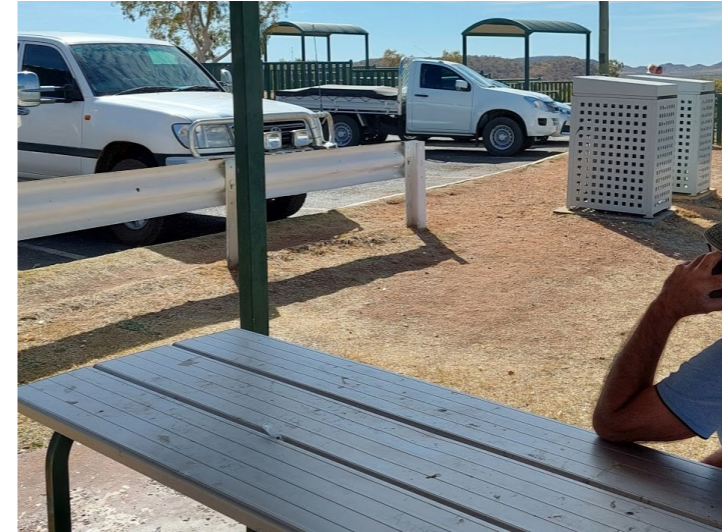
Carpark barriers are bulky and dated, tables are dirty and litter everywhere.

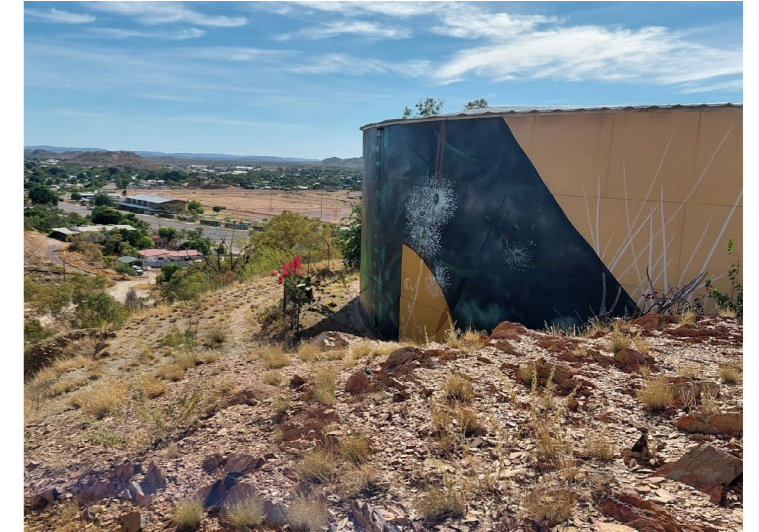
The Water Tank is unable to be viewed in its entirety unless visitors chose to go off track and walk all the way around.

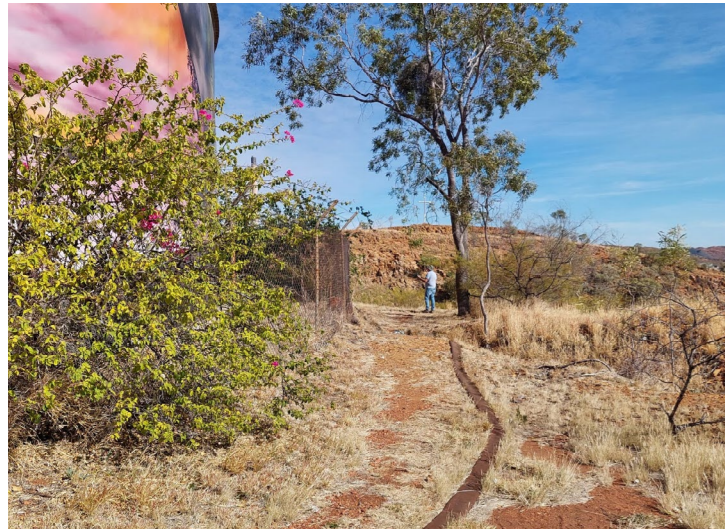
The security fence around the water tank is not necessary as there is CCTV. It is suggested that sections used to enter and/or climb up the tank are fenced off properly. This would allow for the Mural to be fully appreciated.

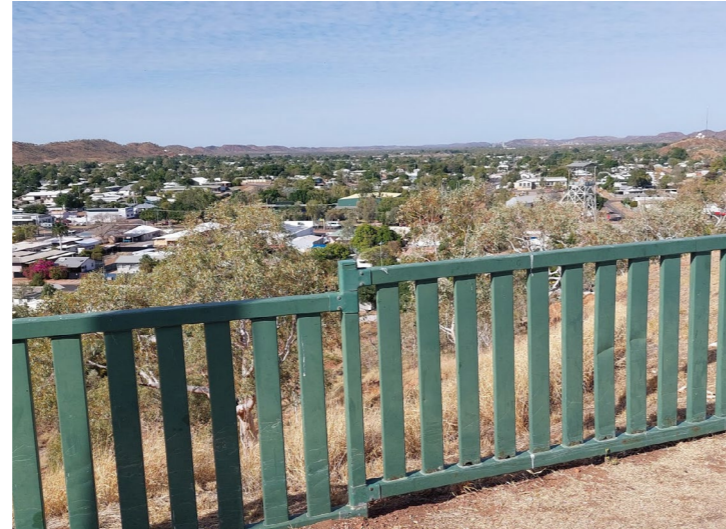
Excessive use of green fencing that is unsightly. The Fence is old and falling apart

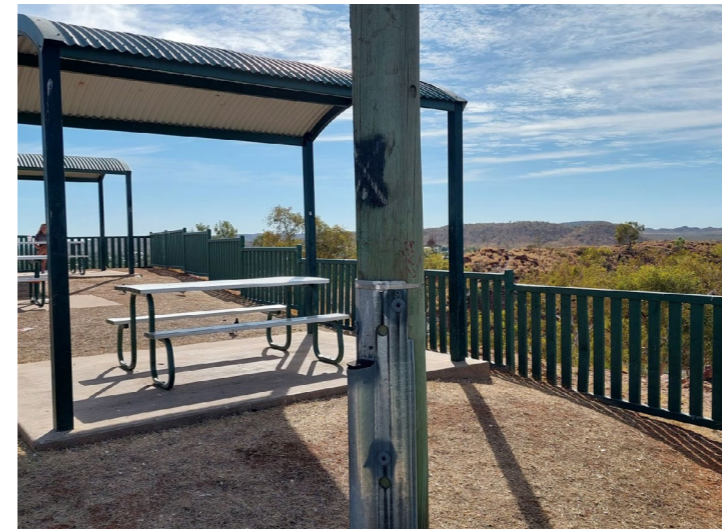
Large covered seating areas are unsightly and do not blend in with the surrounding landscape.

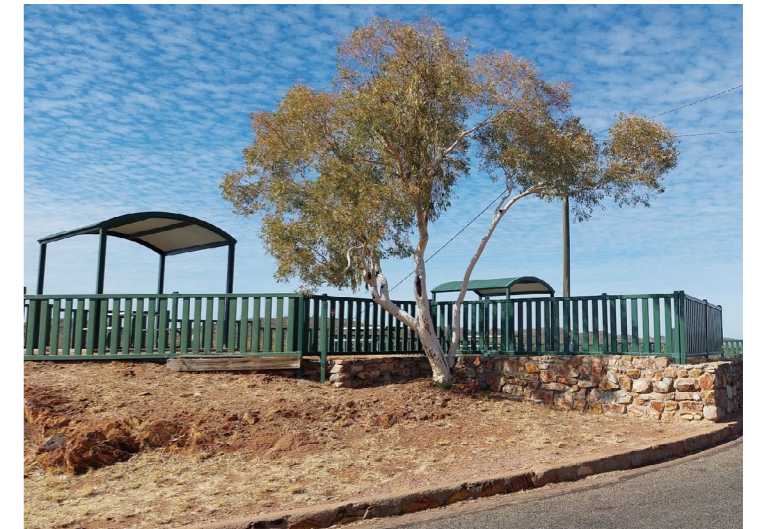
Overuse of structures that stand out which takes the attention off the natural landscape

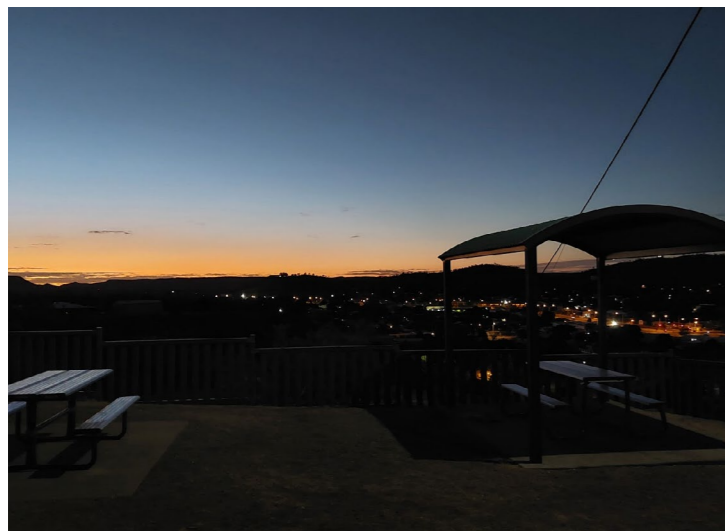
Although the seating area shows off the morning sunrise, the seating area is poorly located and appears to look dissociated from the other sections of the lookout

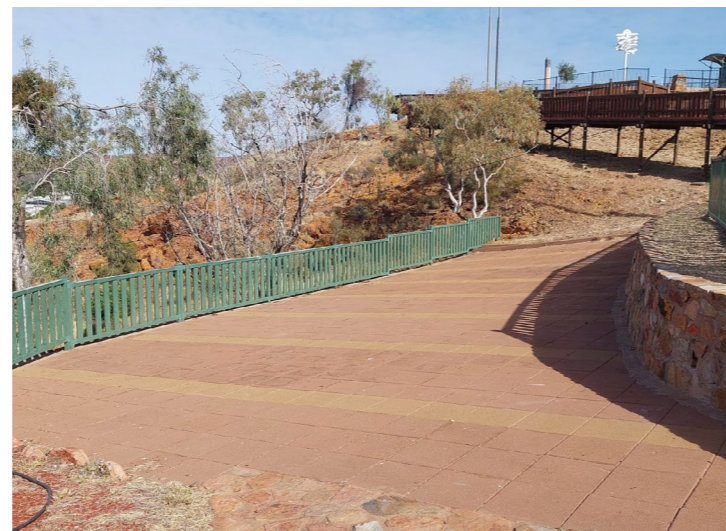
Unnecessary large paved and fenced area that appears to be disconnected from the lookout and it's purpose

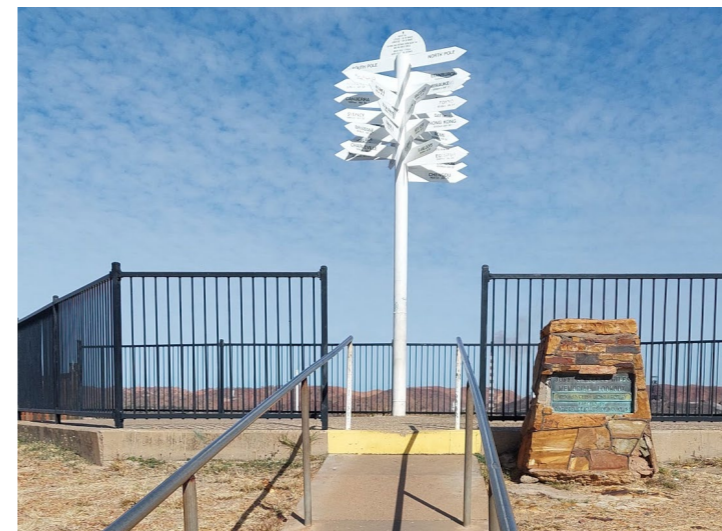
Important memorial is not located well. The direction sign dominate the look out pek and may be better positioned in a redesign.

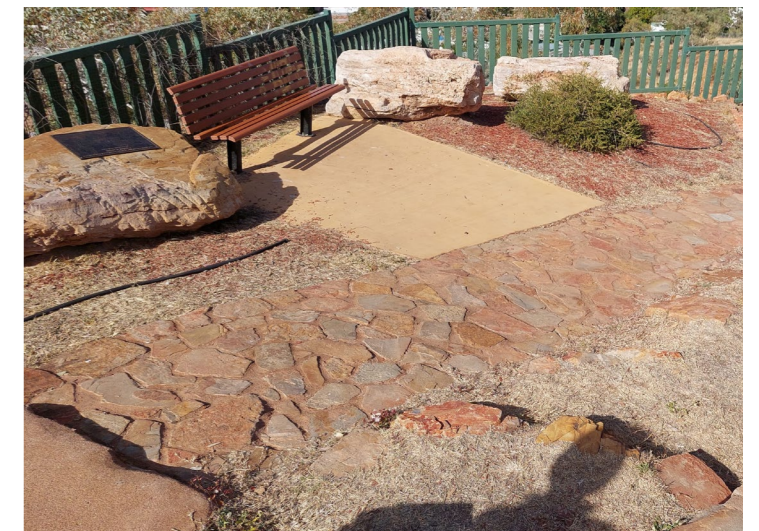
Rock memorial is positioned in its own garden and could be better located.
